Subjects: Dock and Sea Trials "RTA 1" Catamaran Passenger Ferry
Metal Shark Franklin, LA.

The following was observed during my visit of April 27, 2018

First Catamaran Ferry "RTA 1"

Two (2) 32.0 (m) X 7.7 (m) X 1.35(m)RTA Passenger Ferries

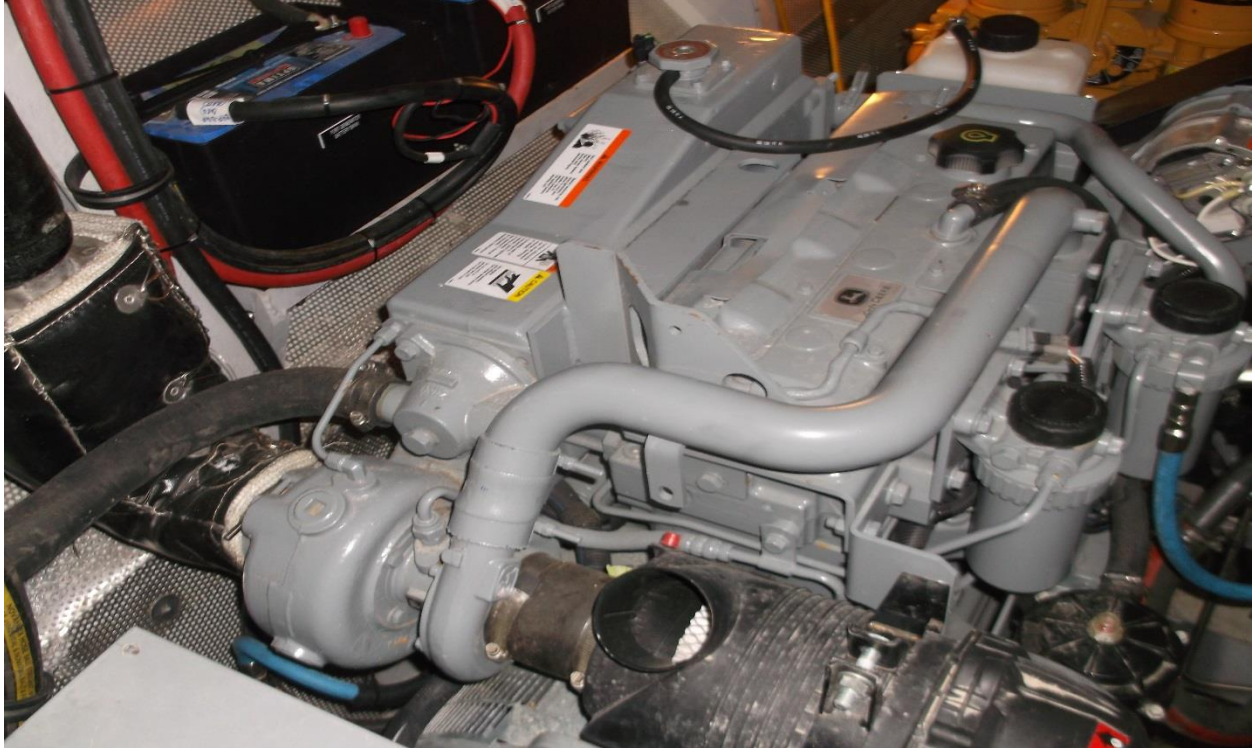
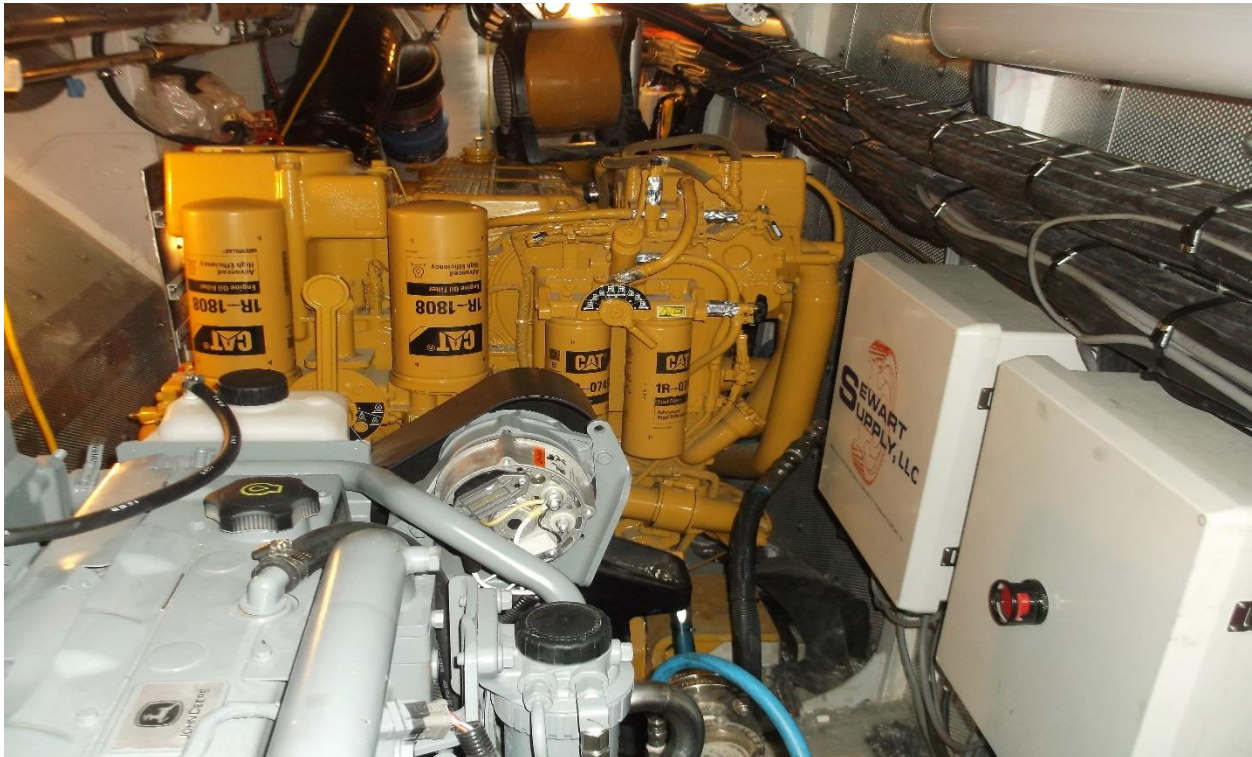
Views of portside generator engine and lower photo looking aft at propulsion engine

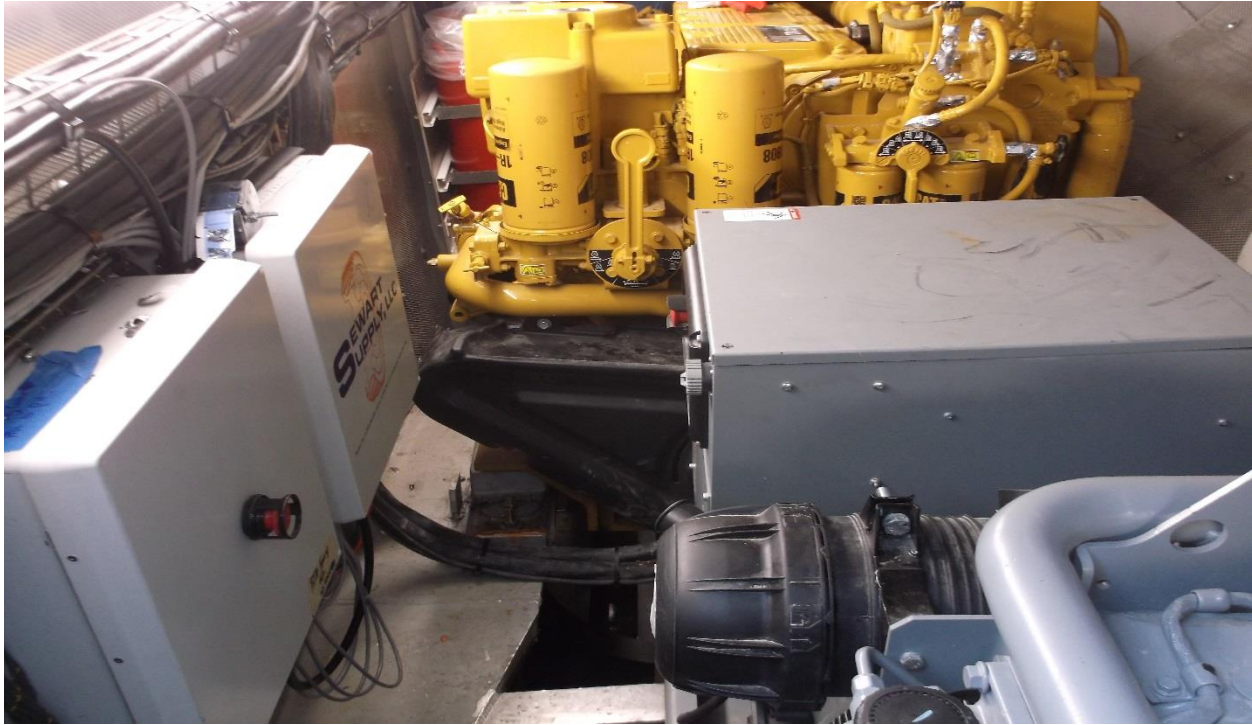
Aft view of portside generator engine/armature and partial view of main engine

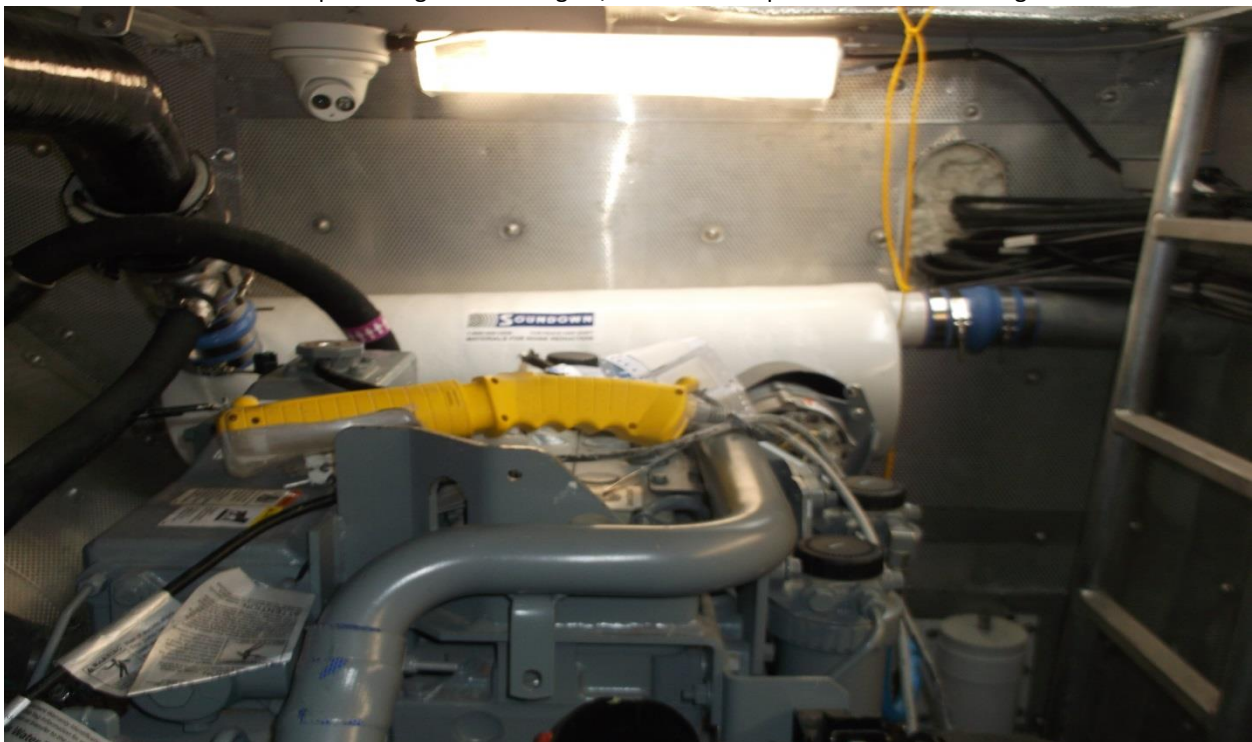
View looking forward at generator engine inside the forward portside machinery space

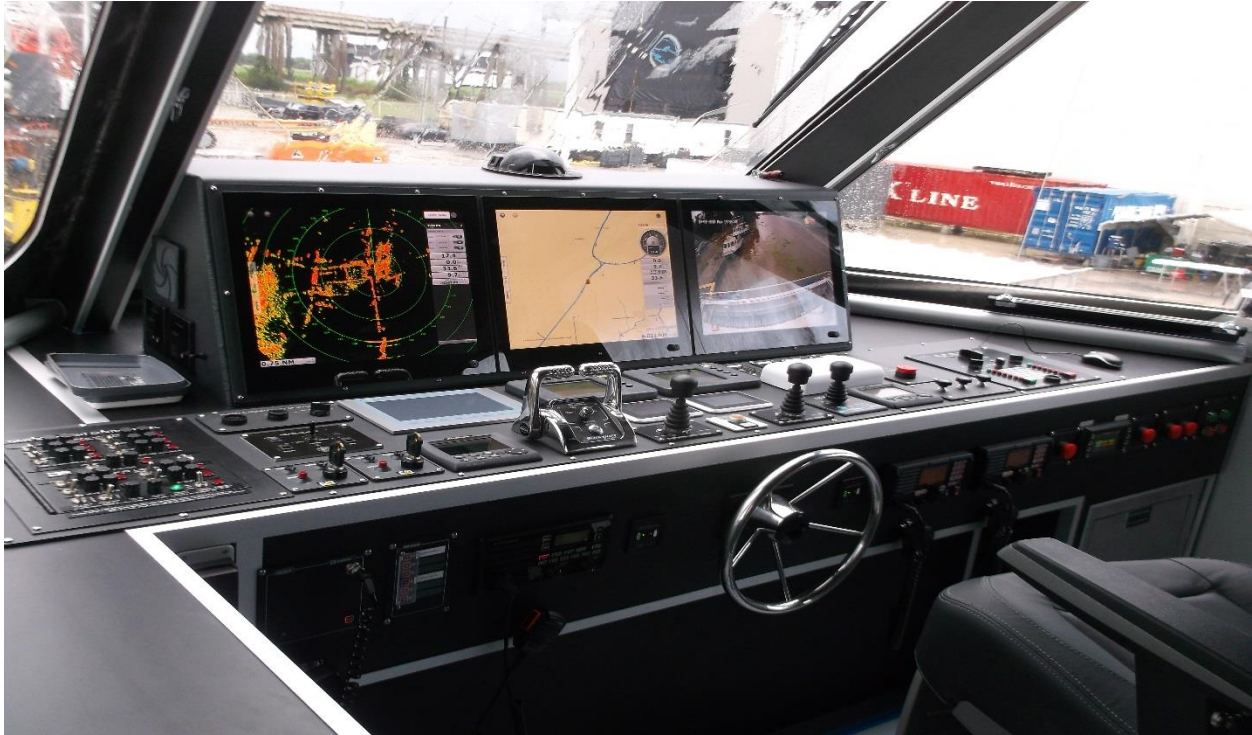
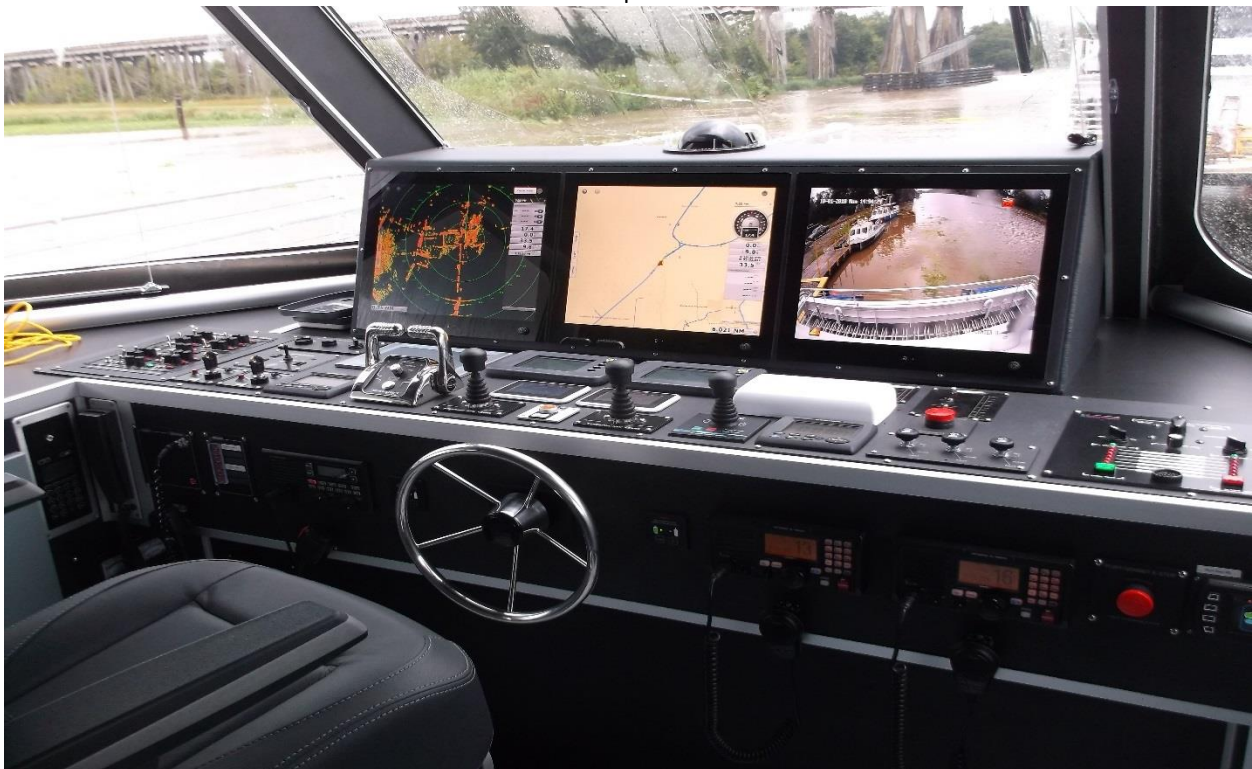
Views of console from port and starboard side

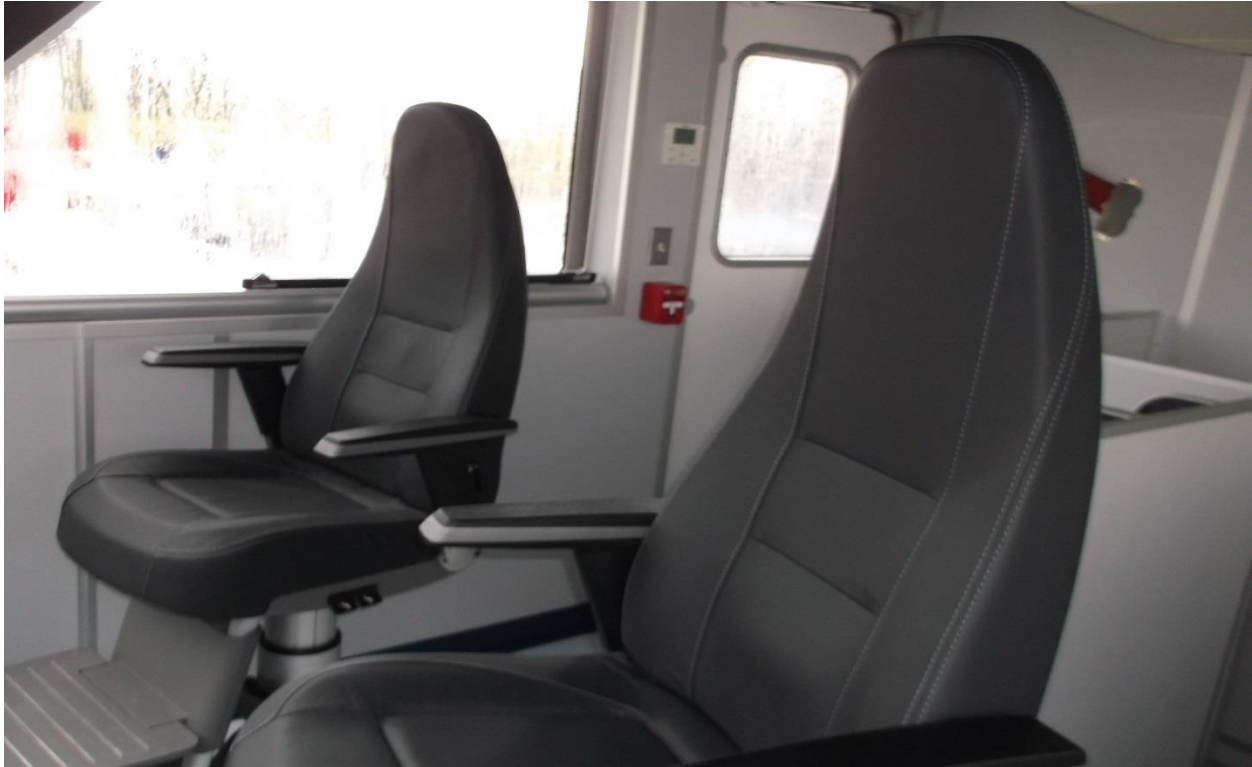
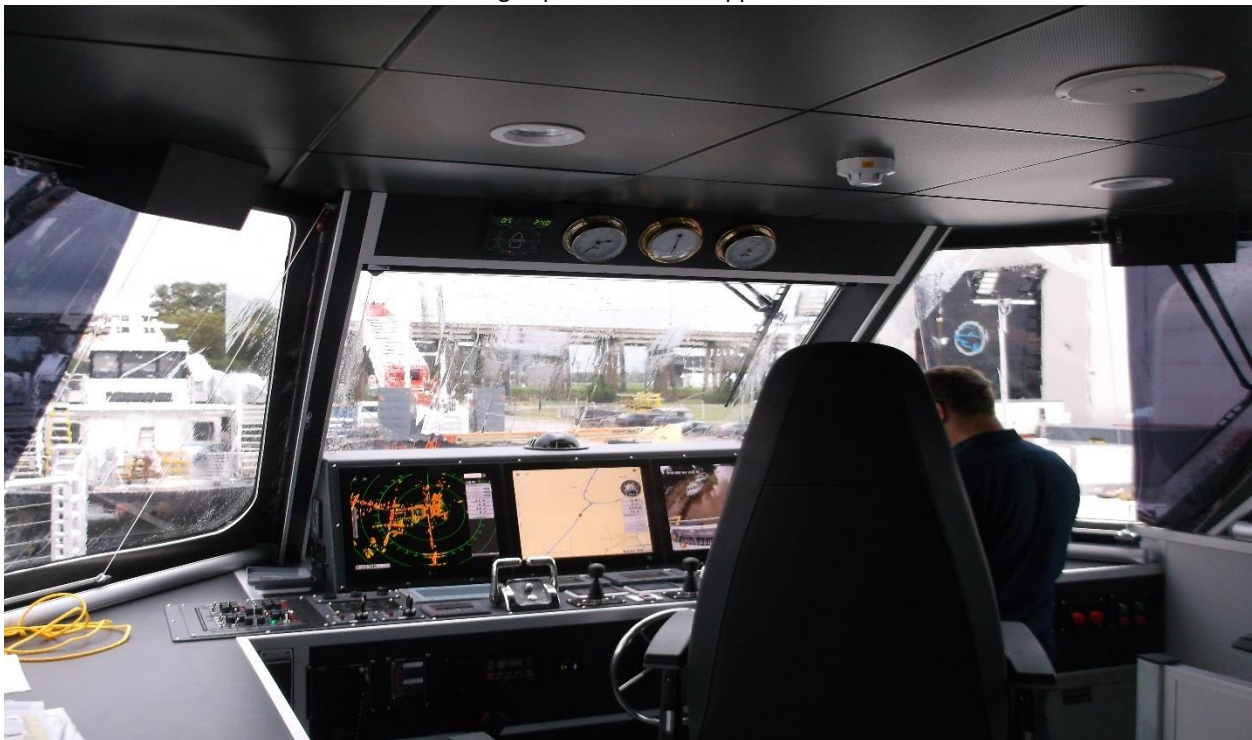
View of seating in pilothouse and upper overall view

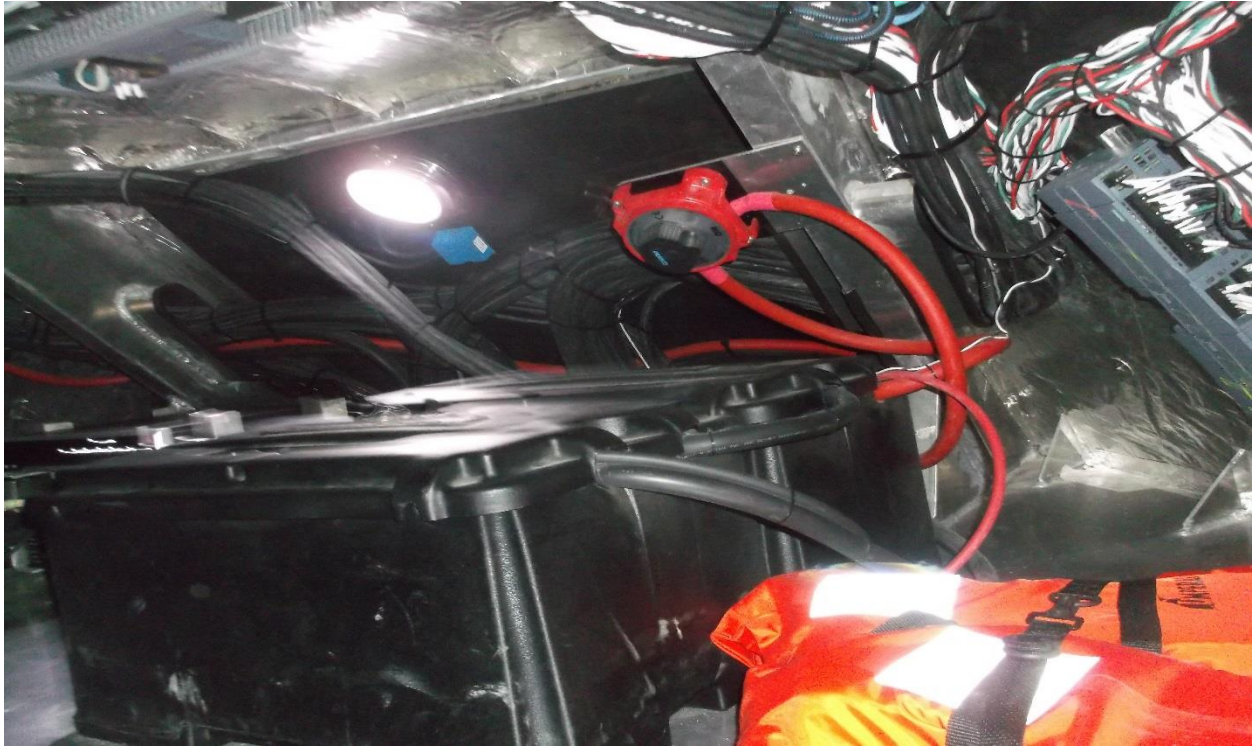
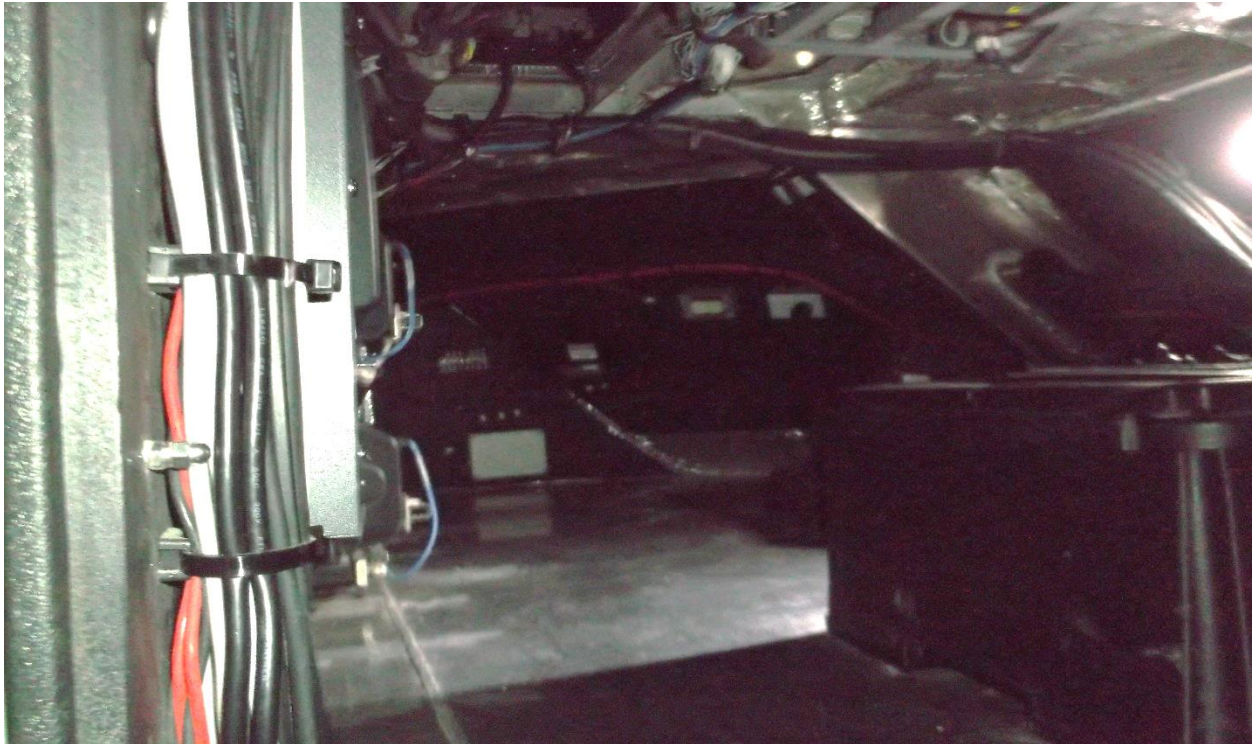
Views inside console of PFDs, backup batteries and other various components

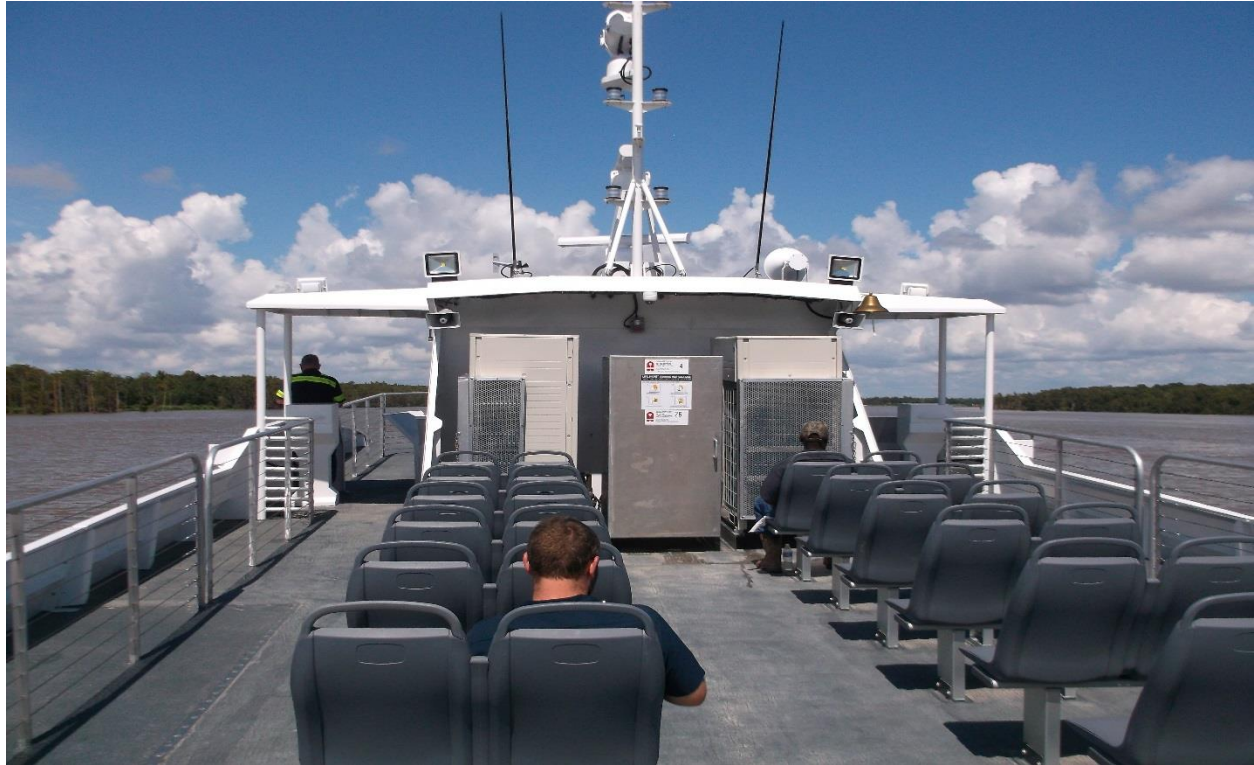
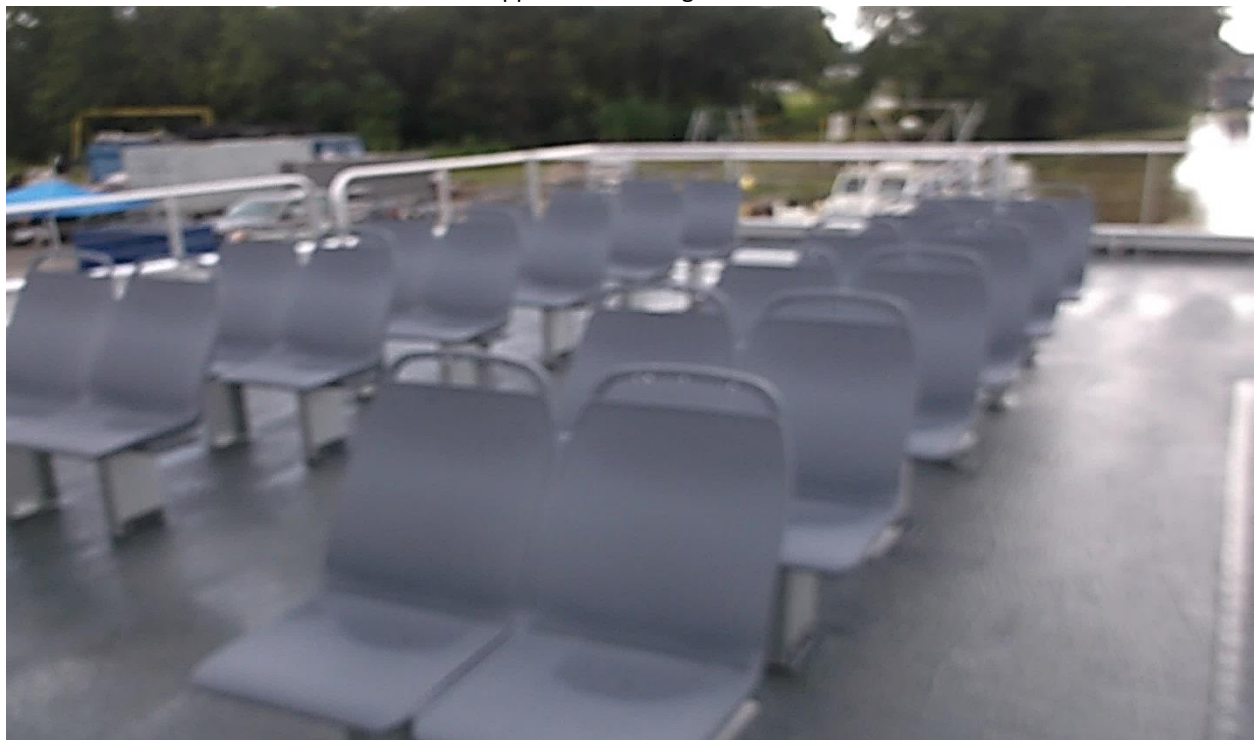
Views of upper deck looking forward and aft

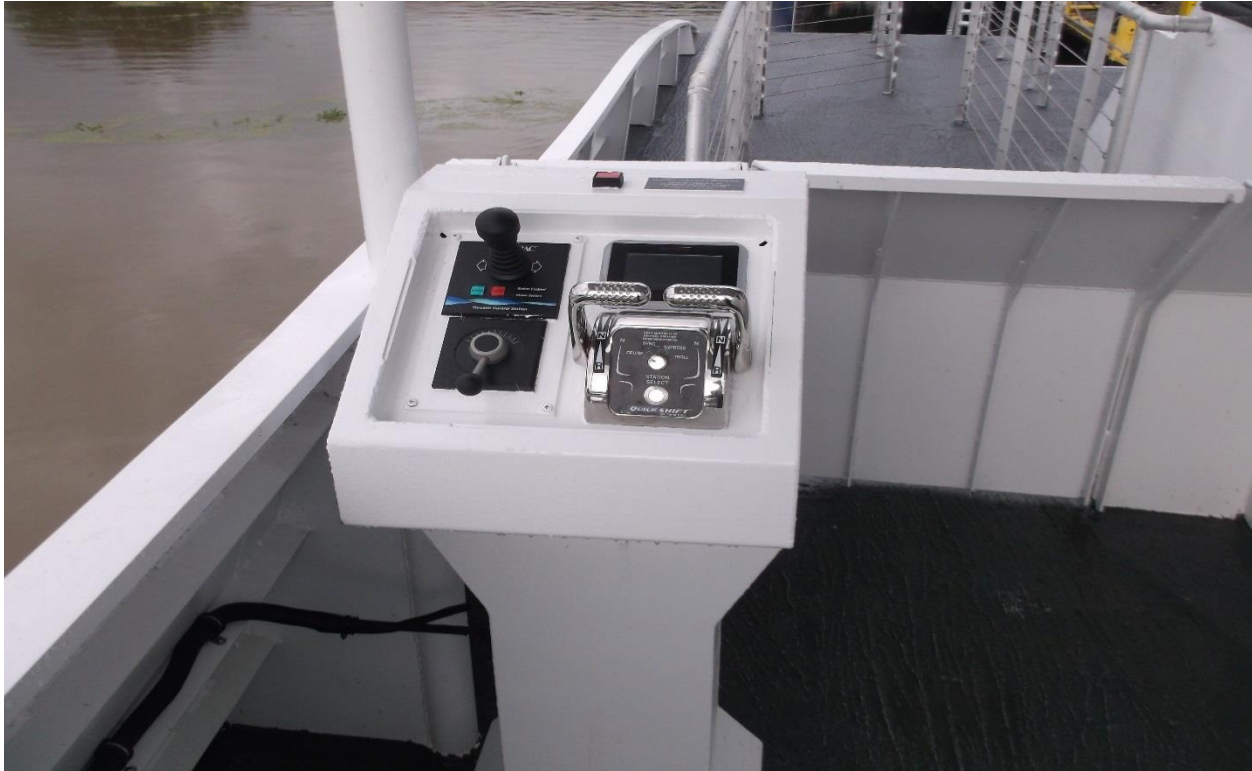
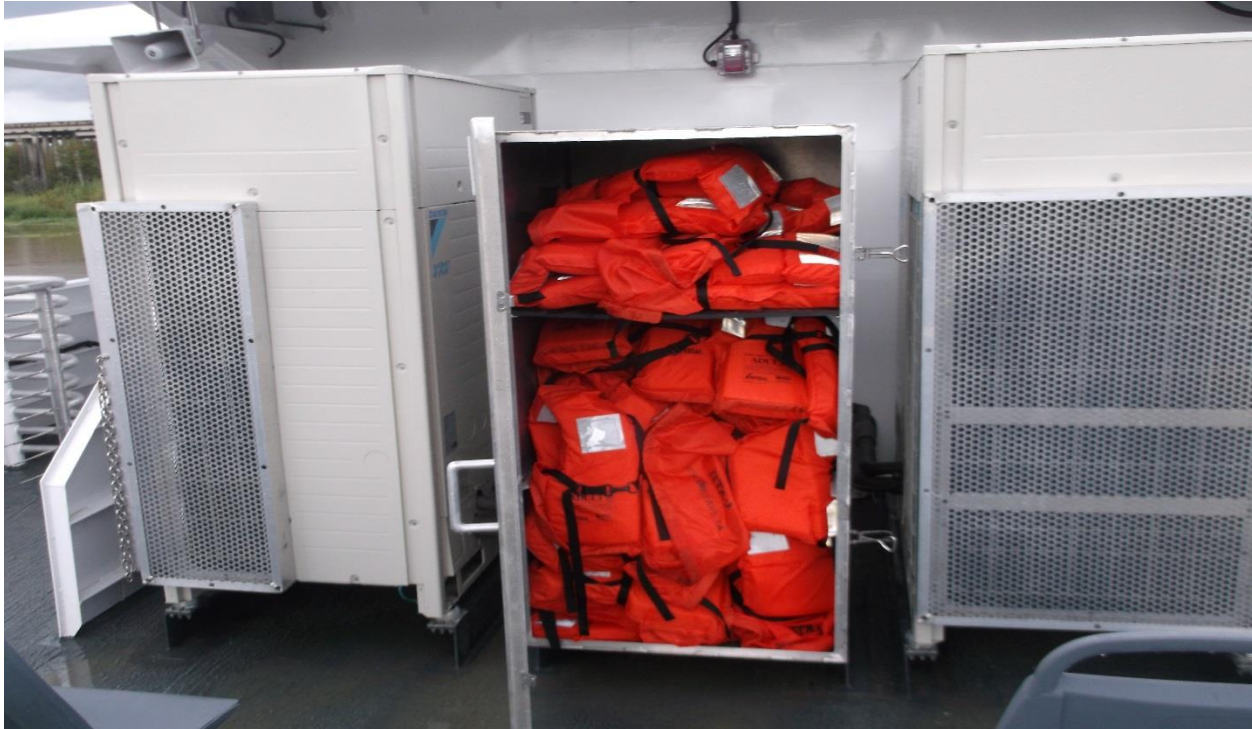
Typical view of upper deck wing station controls and PFDs storage and HVAC condenser units aft of pilothouse

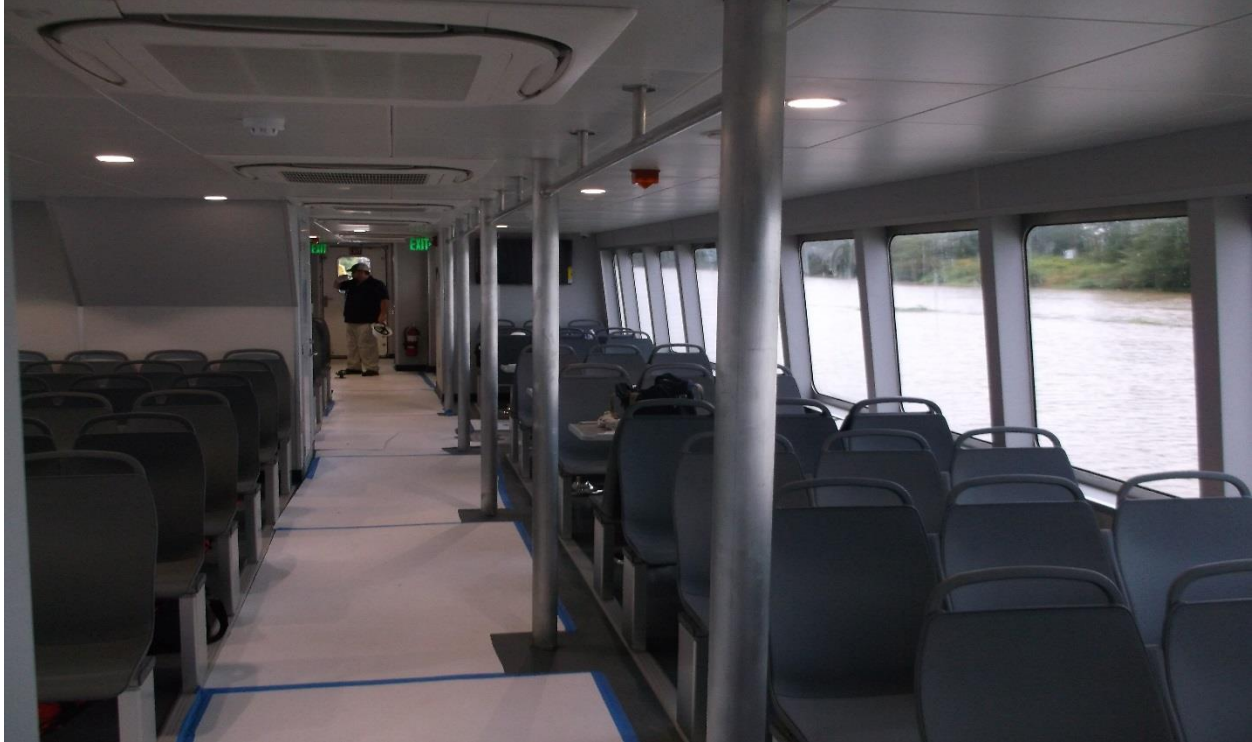
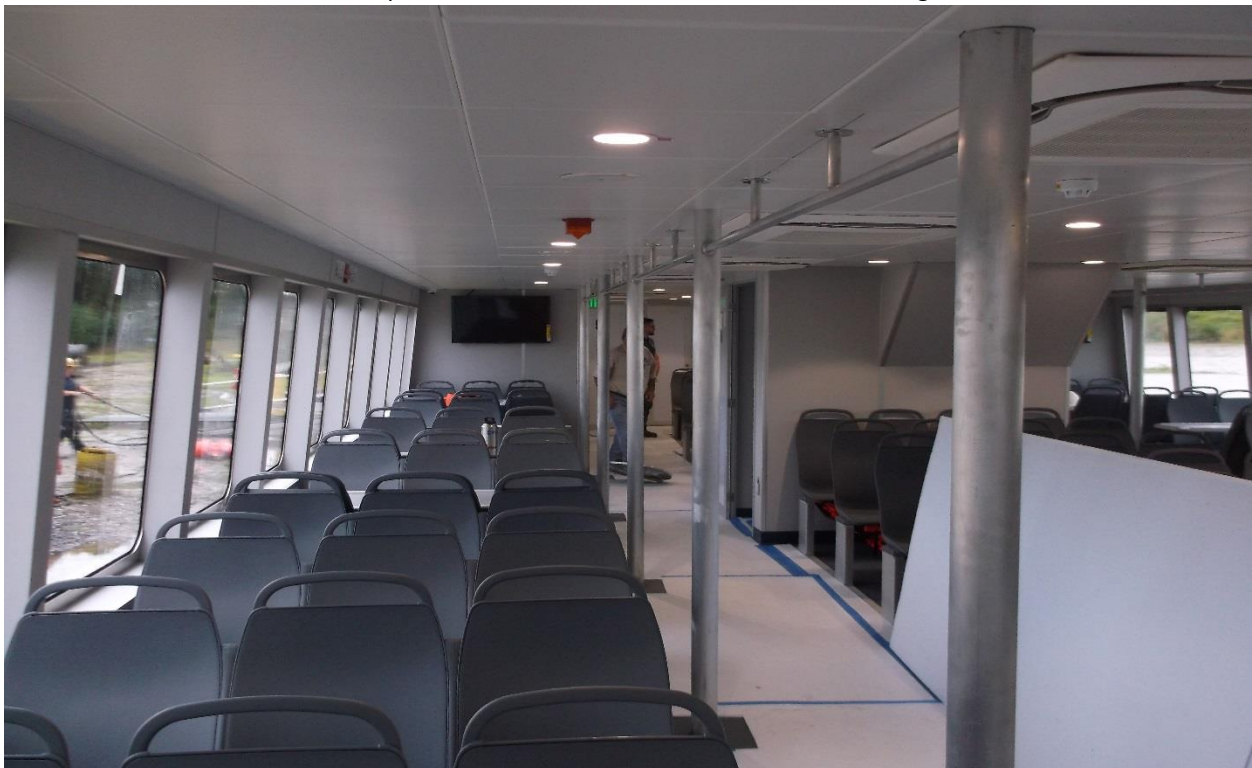
Views of port and starboard sides inside deckhouse looking aft

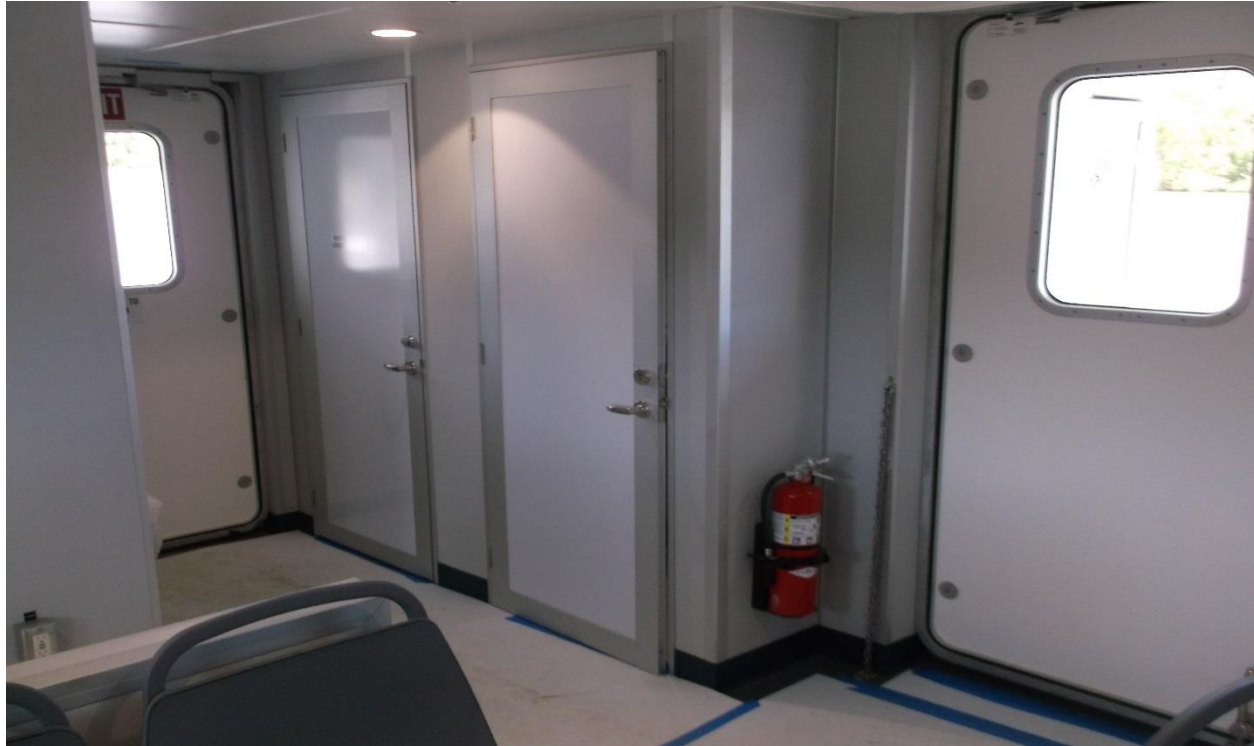
Views of aft port and starboard sides of deckhouse

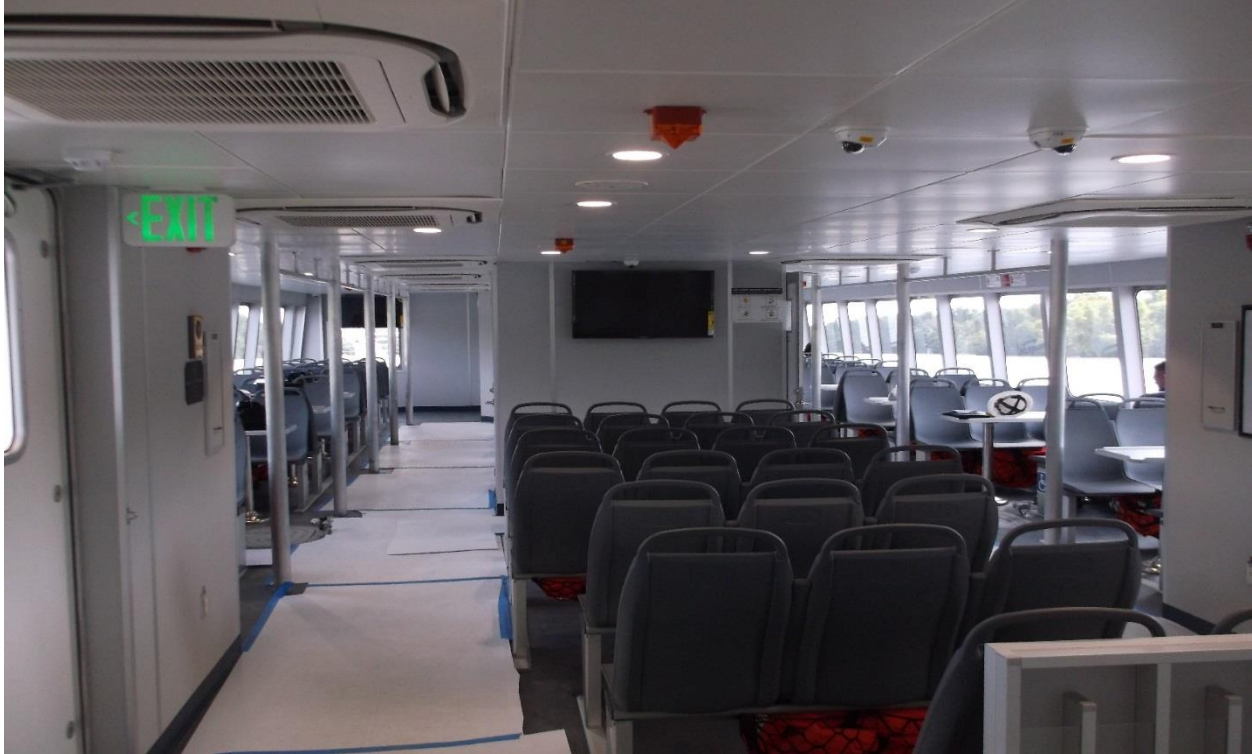
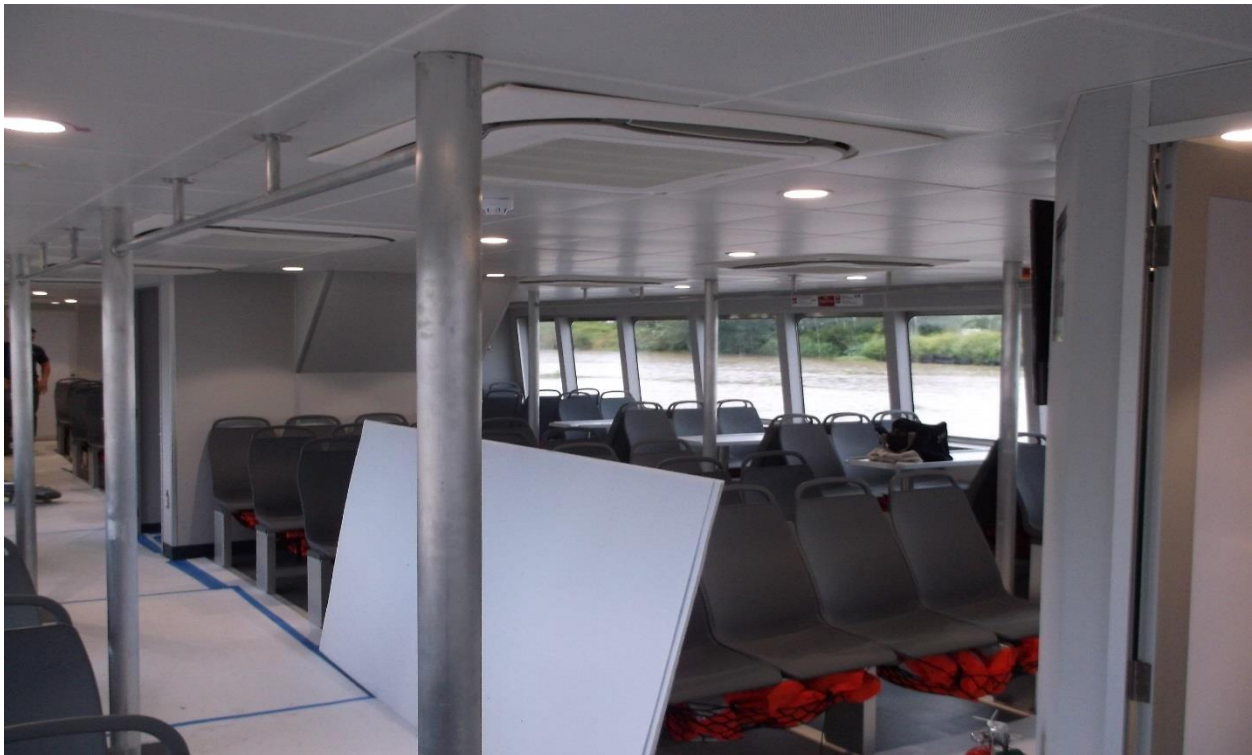
Aft and forward views of deckhouse centerline

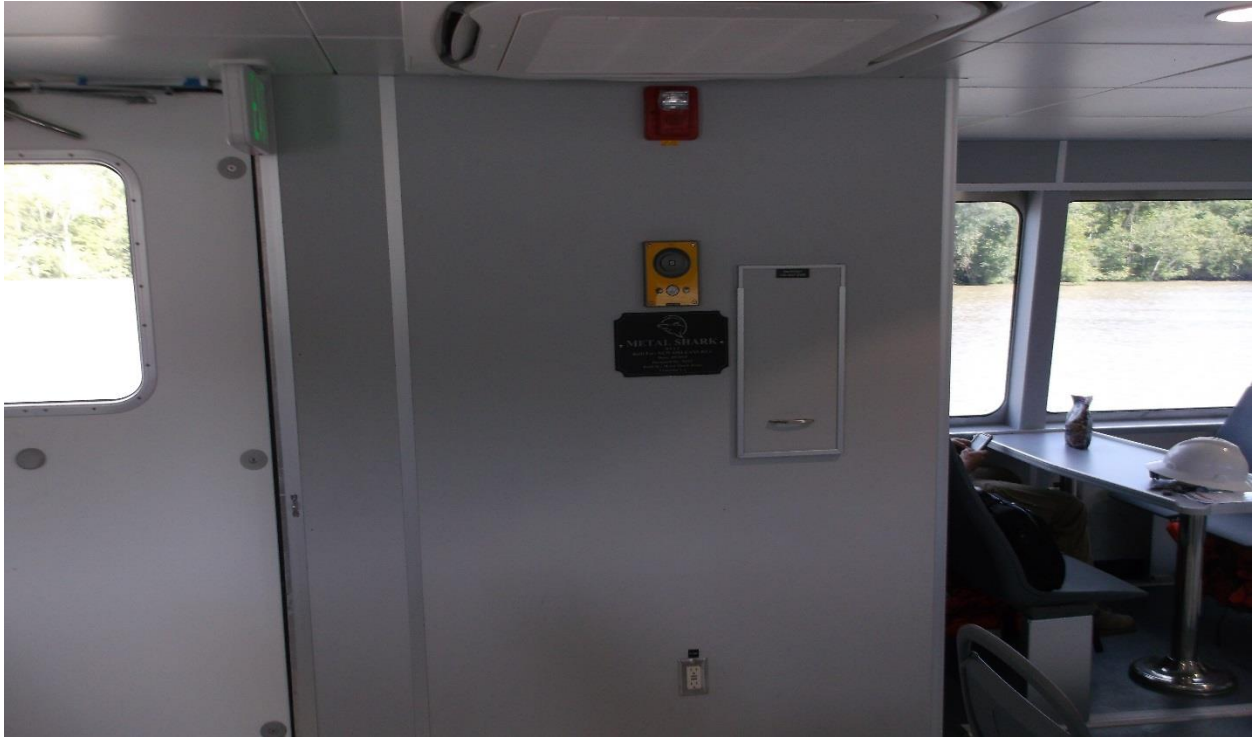
Portside view near double exterior doors of fire alarm, hailing station and emergency fuel oil shut-down station

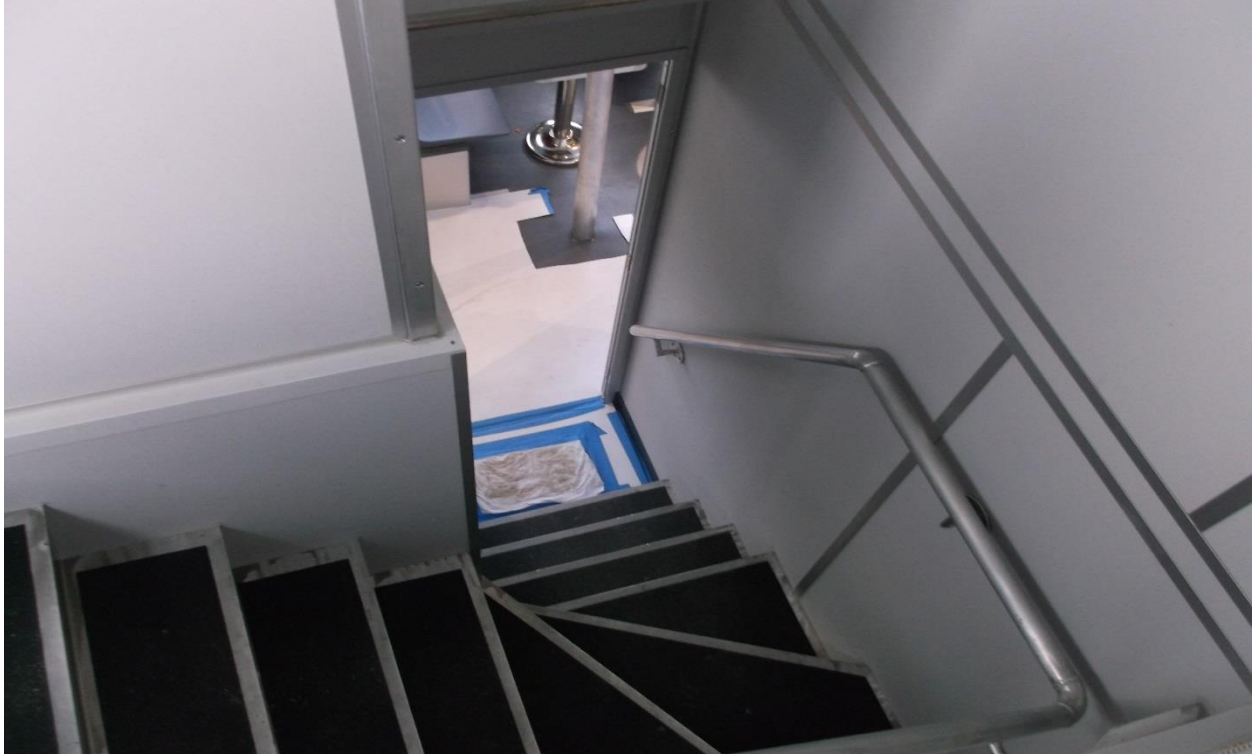
Stairs and handrails from pilothouse and under stair storage having portable bilge pump and fuel stripping sticks

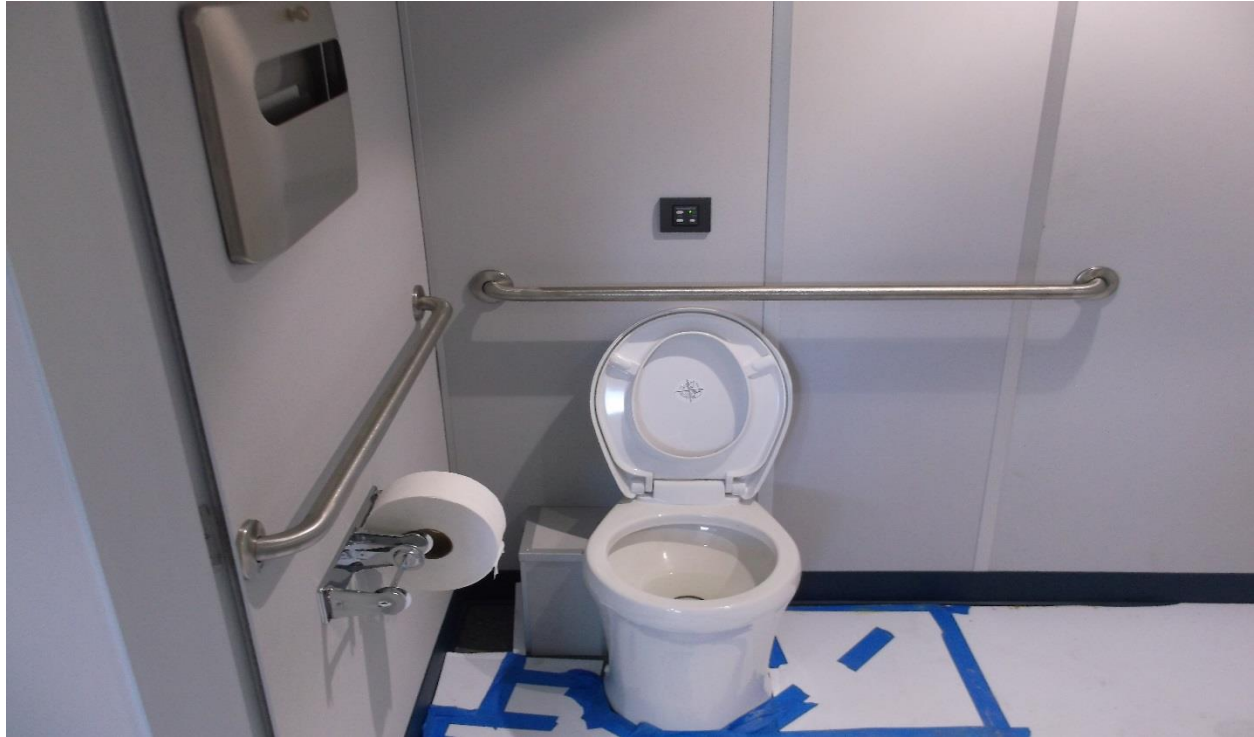
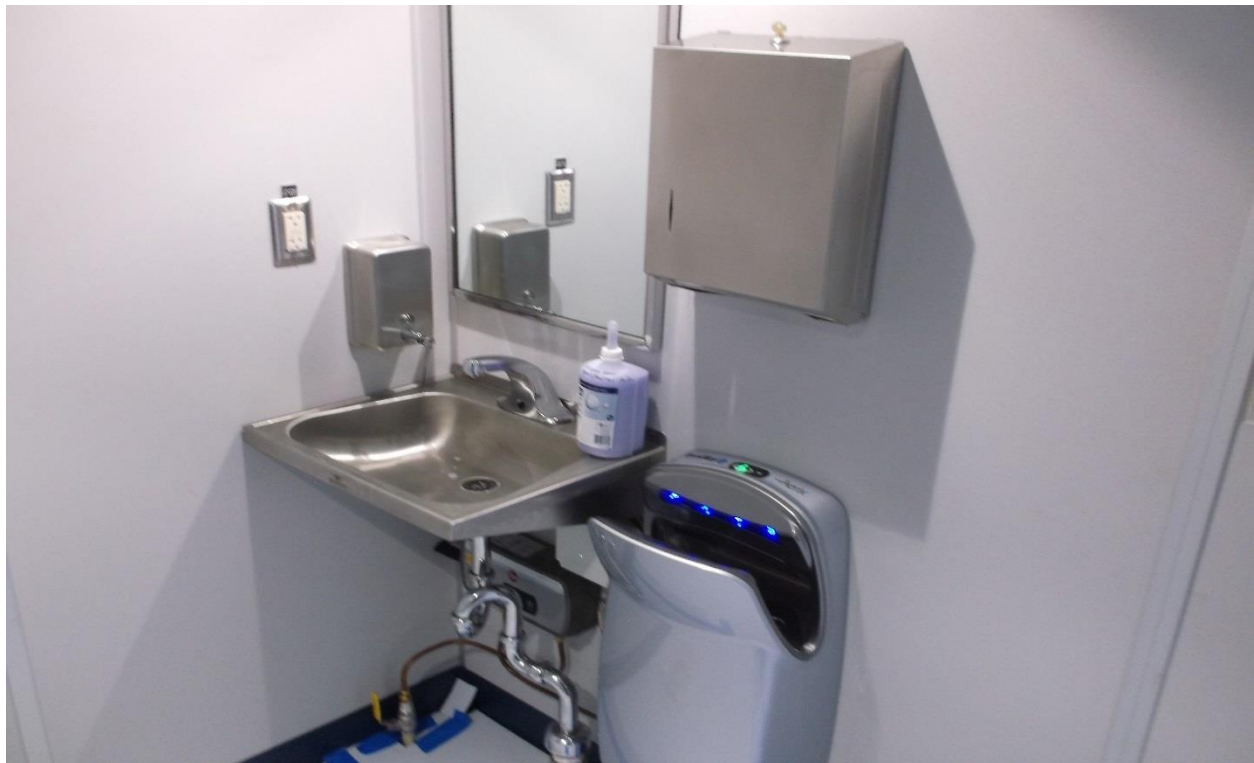
Views inside ADA head
